Manhole Inspection Summary

Manhole # S33SS1005MH

Insp Date: **7/16/08 11:50 AM**

Location Address: **335 SOUTHWAY** Cross Street: **HOMELAND AVE**

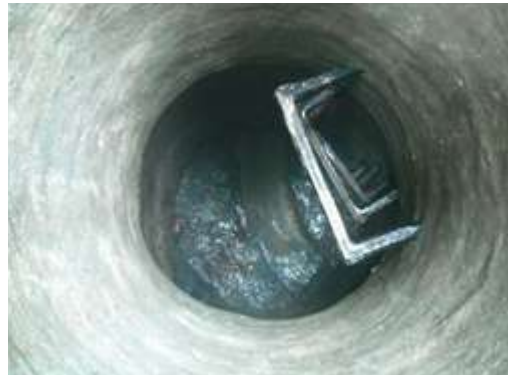
Top View

Comments **Bolted manhole.**
